K8 and K8 B

Operating Instructions
for the Sailplane
Schleicher K8 and K8 B

SHEET: 1 of 3	Technical Note for	Alexander Schleicher GmbH & Co. Regelflugzeugbau D-6416 Poppenhausen
<u>Glider model:</u>	Ka 2 u. Ka 2B TN-No. 11 Ka 6, 6/C, 6B, 6BR, 6CR, 6E-5 . . . TN-No. 21 K7 TN-No. 18 K8, K 8B, K 8C TN-No. 23 K9 TN-No. 1 K11 TN-No. 1 ASK 13 TN-No. 12 ASK 18, ASK 18B TN-No. 6	
<u>Serial number applicability:</u>	Ka 2, Data-Sheet No. 140, all serial no.s Ka 2B, Data-Sheet No. 203, all serial no.s Ka 6, Data-Sheet No. 205, all serial no.s Ka 6/C, Data-Sheet No. 205, all serial no.s Ka 6B, Data-Sheet No. 205, all serial no.s Ka 6BR, Data-Sheet No. 205, all serial no.s Ka 6CR, Data-Sheet No. 205, all serial no.s Ka 6E5, Data-Sheet No. 205a, serial no. E1 K7, Data-Sheet No. 211, all serial no.s K8, Data-Sheet No. 216, all serial no.s K8B, Data-Sheet No. 216, all serial no.s K8C, Data-Sheet No. 216, all serial no.s K9, Data-Sheet No. 221, serial no. 1 K11, Data-Sheet No. 668, serial no. V1 ASK 13, Data-Sheet No. 357, all serial no.s ASK 18, Data-Sheet No. 307, all serial no.s ASK 18B, Data-Sheet No. 307, all serial no.s

AIRWORTHINESS DIRECTIVE

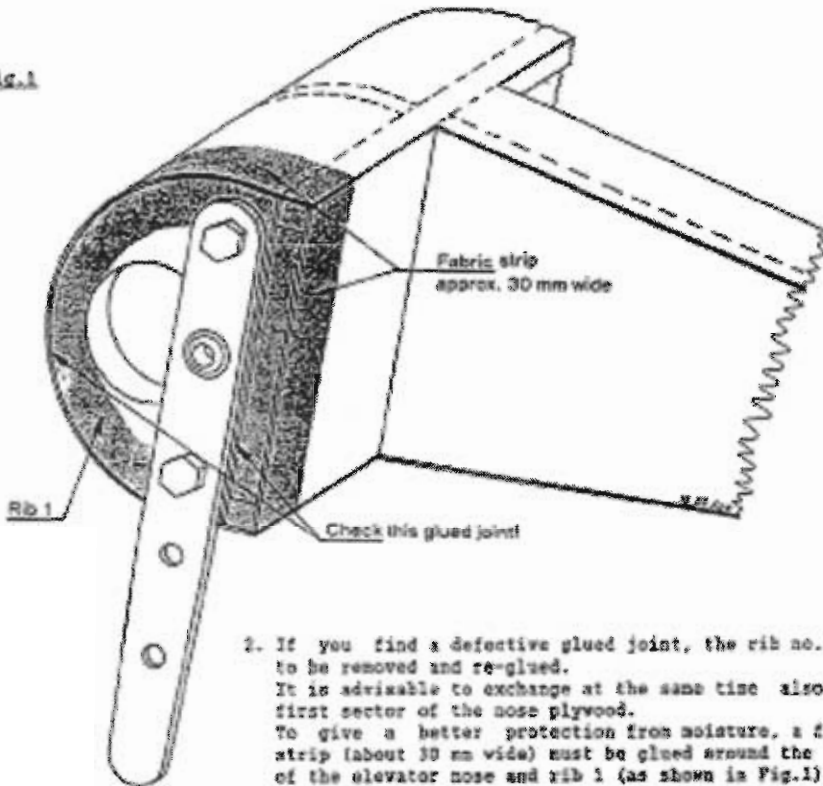
Fig.1

<u>Subject:</u>	Elevator.	
<u>Compliance:</u>	Prior to the next take-off.	
<u>Reason:</u>	A glider of the model K7 failed to gain normal flight altitude immediately after tow rope release on winch launch. With the stick full back only the left elevator could be actuated in the correct direction; the right elevator deflected downwards. The reason for this was a loose glue bond at the elevator rib 1 at which the elevator fitting is attached. Similar incidents had already before to the issue of the LTA 72-7 dated Feb.9,1972.	
<u>Action:</u>	1. Remove elevator. Check that the glued joint between rib 1 and the leading edge plywood and the elevator spar respectively is in good condition (see Fig.11). Before doing so check whether the LTA 72-7 of Feb.9, 1972 was already previously accomplished (this is not applicable to K9, K11 and ASK 18); if yes then the fabric strip first carefully has to be detached in order to be able to check the glued joint.

2. If you find a defective glued joint, the rib no.1 has to be removed and re-glued. It is advisable to exchange at the same time also the first sector of the nose plywood. To give a better protection from moisture, a fabric strip (about 30 mm wide) must be glued around the edge of the elevator nose and rib 1 (as shown in Fig.1).
3. The above action under points 1. and 2. must be repeated every three years during the annual re-inspection. This copy of the Technical Note must be inserted in the Flight and Operations Manual of the respective glider as an annex and a corresponding entry must be made into the "Amendments to the Manual".

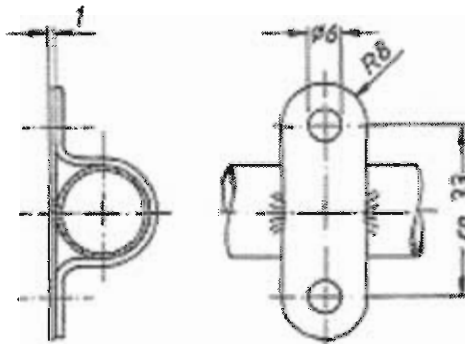
Fig. A2

- ad A2) Checking the rudder pedals:
With the rudder neutral the pedals left and right must be evenly adjusted. Check the pedal board angle versus the pedal dimensions see drawing L-216.42-U011. The angle must meet the specified dimension.
Engage the pedal adjustment into its foremost position and check full deflection of the rudder.
Where pedals or attachment collars are bent, these can be either repaired or replaced by new ones.
In order to impede the bending of the pedal boards it is optionally recommended to weld an additional butt strap onto the attachment collar (see Fig.A2).

Reinforcing the attachment collars for pedal boards at the pedal assembly. Material: 1.7734.4
Welding procedure WIG to spec DIN 1912, welding wire material: 1.7734.2
